Geotechnologies Applied to Anthropomorphic Structures: Use of GPR for Detection of Structural Problems, Causes and Effects - Case Study in Coimbra, Portugal

This study was carried out in central Portugal, in the city of Coimbra, integrated into urban development at the location indicated in figure 1. The implantation of the structure is in the bedrock belonging to the Grés de Silves Formation [10].

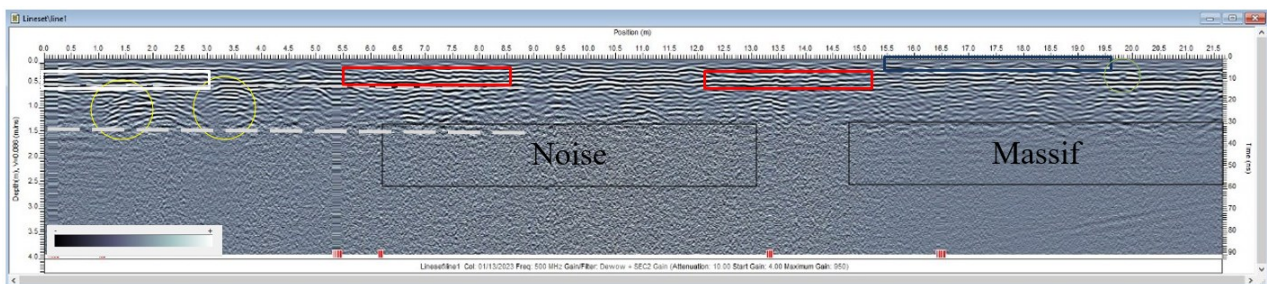
Fig. 6. Radargram Lineset 1. East acquisition. Processed.

The results obtained from the acquisition performed on the East side (Lines 1, 2 and 3), show that on the surface, as expected, no significant changes were identified, and it is possible to see the floor slabs (blue polygon). At a depth of 0.50-0.55 m, marked by the red polygon, it is possible to identify the beam and the reinforcements, as well as the stratified area (white polygon). It is also possible to identify what appears to be a box and pipes (yellow and green circles). From 1.1-1.15 m depth, for the radargrams of lines 1, 2 and 3, the signal is different, partly due to the rocky substrate in which the structure is set (grey dashed line). There is also a lot of noise below this depth from signal attenuation due to the materials above (rock with high content of iron and clay and seepage water). All this structure is visible on the remaining processed radargrams (Figures 6, 7 and 8).

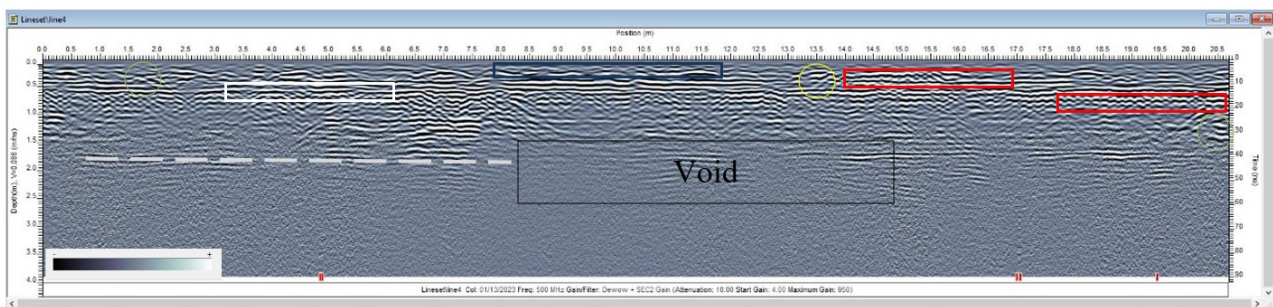
Fig. 9. Radargram *Lineset 4*. South acquisition. Processed.

On the West side (Lines 4 and 5), it can also be seen that on the surface, no significant alterations are observed, and it is possible to see the floor slabs (blue polygon). At a depth of 0.50-0.55 m, marked by the red polygon, it is possible to identify the beam and the frames, as well as the stratified area (white polygon). It is also possible to identify what appears to be a box and pipes (yellow and green circles). From 1.5-1.7 m depth, for the radargrams of lines 4 and 5, the signal is different and is partially attenuated by the materials above (iron and seepage water) and by the existing void resulting from the built structure (Figure 11) (grey dashed line). All these structures are visible on the remaining processed radargrams (Figures 9 and 10).

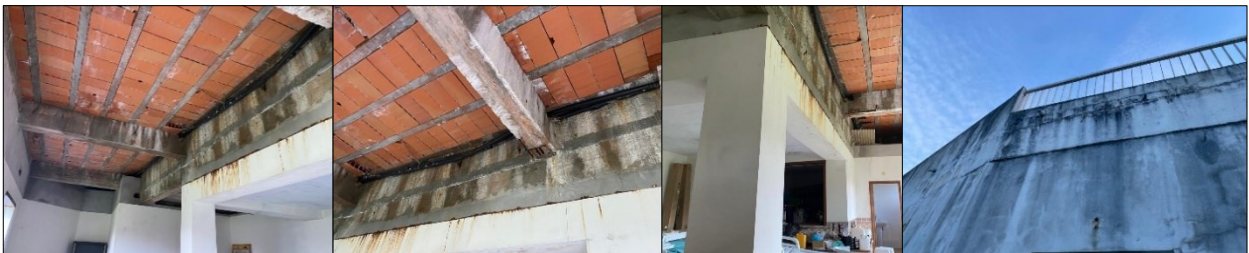
Fig. 11. Interior and exterior of the structure correspondent lines 4 and 5.

At 0.35-0.40 m depth, corresponding to the slab, there are some significant changes with high reflectance values on the East side, possibly corresponding to water infiltration in the rock mass and on the west side to water infiltration in the contact between the pool and the slab, at the point where there are higher reflectance values. At a depth of 0.50-0.55 m, the alteration in the structure is notorious. By water infiltration and the presence of iron from the beams of the structure. As can be seen in figure 11, the frames are bare and with high rates of deterioration. From 0.65-0.70 to 1.65-1.70 m depth, the variations in reflectance values tend towards uniformity and lower values. This fact is because underneath the deteriorated structure there is an open space which corresponds to the interior storage space of equipment and machinery related to the swimming pool maintenance (Figure 11). In the last slice, it is possible to identify a change in the southwest corner, which will correspond to an occurrence in the masonry wall built in the structure, as can be seen in the last photograph of Figure 11.

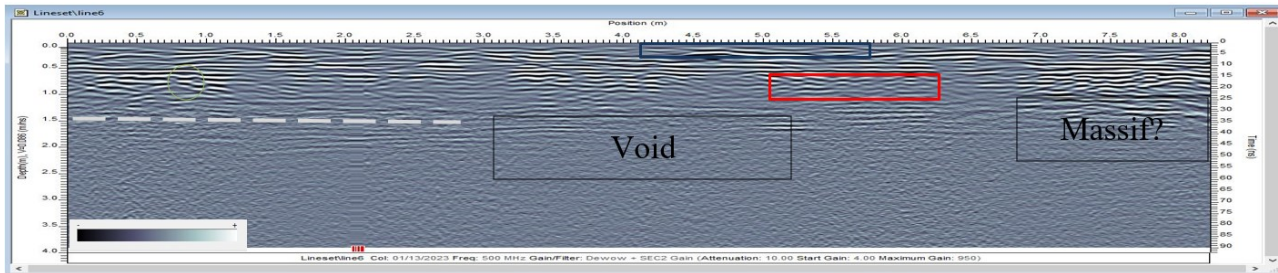
Fig. 12. Radargram *Lineset 6*. West acquisition. Processed.

On the South side (Lines 6 and 7), it is also possible to see no significant changes on the surface, with the floor slabs being visible (blue polygon). At a depth of 0.60-0.70 m, marked by the red polygon, it is possible to identify the beam and the frames. It is also possible to identify what appears to be piped (green circle). From 1.5-1.7 m depth, for the radargrams of lines 6 and 7, the signal is different and is partially attenuated by the materials above (iron, rock with high iron and clay contents and infiltration water) and by the existing void resulting from the built structure (grey dashed line). All these structures are visible on the remaining processed radargrams (Figures 12 and 13).

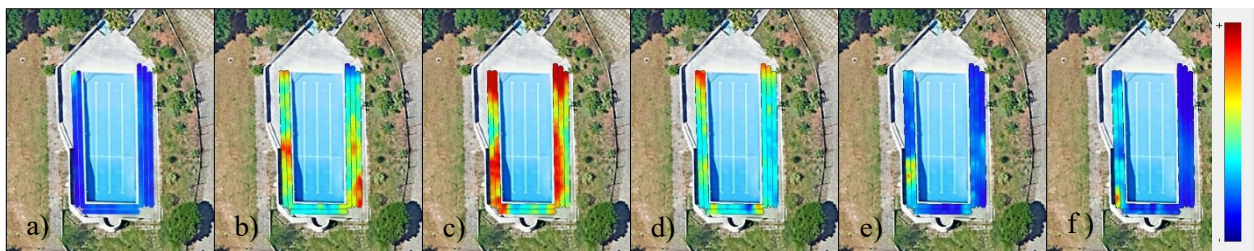
At the surface, as it had been referred from the visualisation of the radargrams, there are no significant changes mirrored in the uniformity of the reflectance values. In this case, the surface was dry and structurally sound.

Fig. 14. a) Surface Slice. b) Slice to a depth of 0.35-0.40 meters. c) Slice to a depth of 0.50-0.55 meters. d) Slice to a depth of 0.65-0.70 meters. e) Slice to a depth of 1.10-1.15 meters. f) Slice to a depth of 1.65-1.70 meters.
