Thermography of the Extensive Green Roof of the Brno-Komín Kindergarten

The article deals with the behavior of an extensive green roof in winter. The behavior of the green roof of the Kindergarten Brno – Komin is described in the case study. The condition of the roof was determined using thermovisual technology. An extensive green roof shows significant temperature differences in winter compared to roofs without vegetation. The vegetation layer on roofs partially acts as an insulating layer. From this structure, the ventilation shafts and sanitary equipment emerge thermally. As part of thermography, the influence of the revision segment on heat conduction was determined. The overall thermal technical condition was evaluated using a thermal camera.

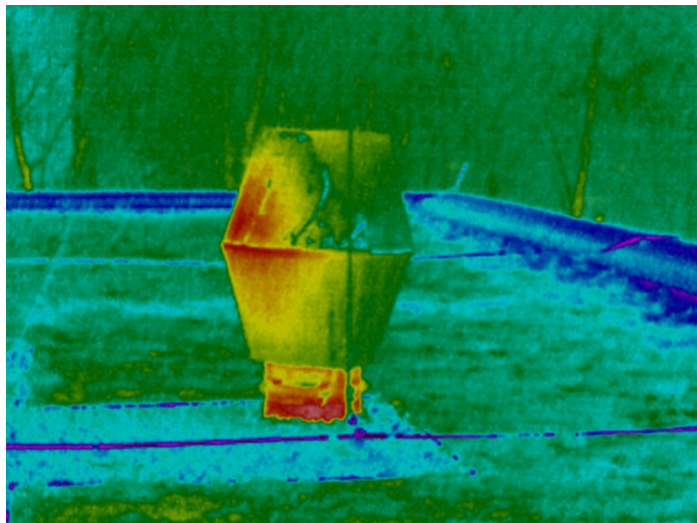
A large difference between the temperature of the air handling unit body and the surrounding material was captured in dark vision images of shaft penetrations. [Figure 1] The lowest temperatures were shown by the construction of the attic sheeting and aluminum profiles around the perimeter of the roof, where the aggregate was poured. Likewise, very low temperatures were experienced by the lightning conductor, which is routed along the entire roof in the shape of a square net. The ventilation shaft was divided into two parts and according to the picture it was clear that only one part of the vent was in use, therefore the body shows a temperature difference on both sides.

Fig. 1. Thermalvision image of the ventilation system

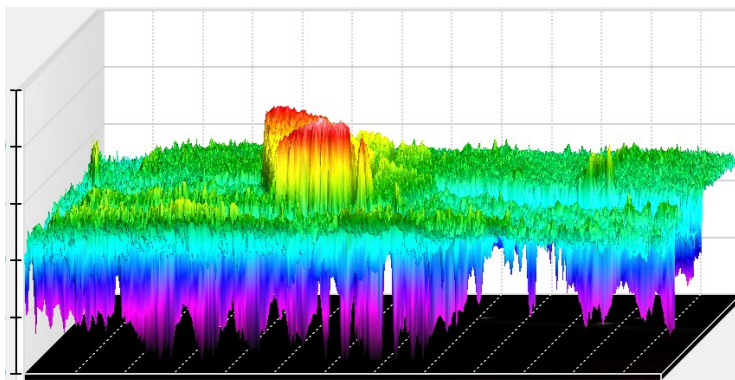
On the contrary, we can see minimal temperature fluctuations in the surface of the substrate and vegetation. The only minor change is in the area where the aggregate is poured. [Figure 2]

Fig. 2. 3D-IR image of the ventilation system

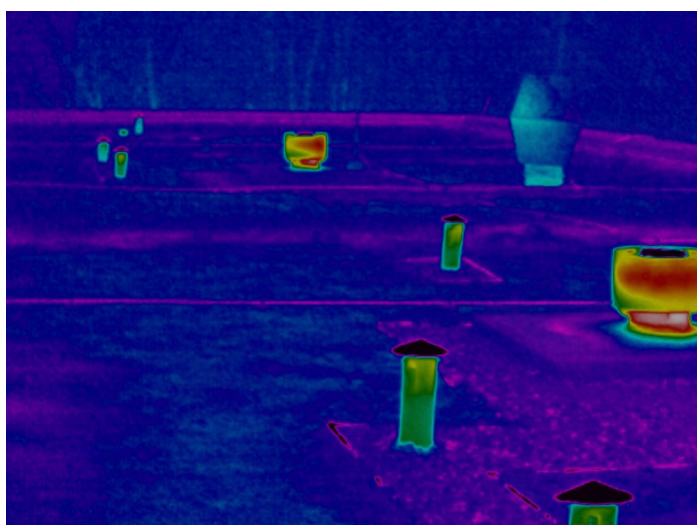
Fig. 3. Thermalvision image of shaft 3D-IR image of the ventilation system

On Figure 3, we can see the temperature differences of the vents of the installations and the surface of the roof. On Figure 4, we can again see the 3D-IR graph of temperatures in the area.

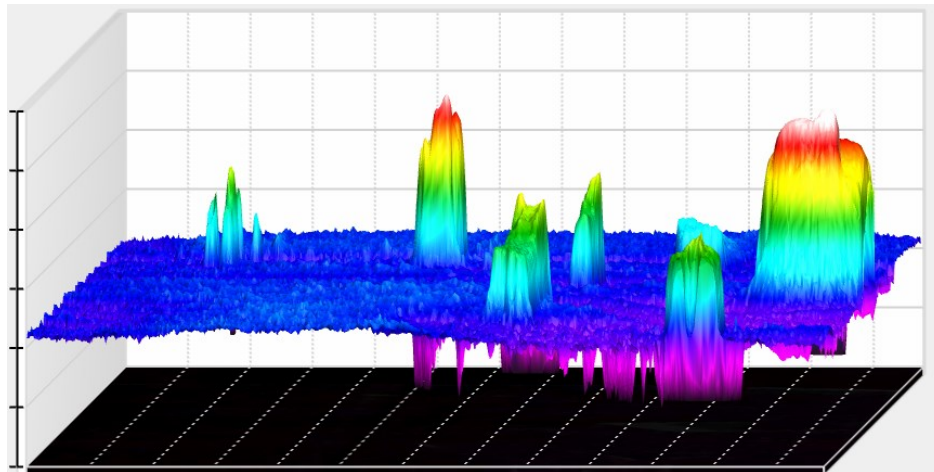
Fig. 4. 3D-IR image of the ventilation chimneys

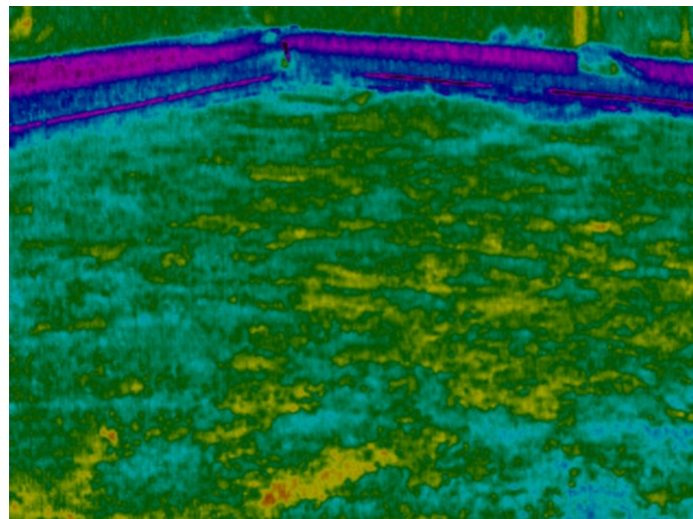
Fig. 5. Thermalvision image of vegetation carpet

The slight differences in the temperatures in the roof surface in Figure 5 were caused by the different thickness of the substrate layer or the partial absence of roof vegetation, even so the temperatures here differed by only 2 to 3°C.

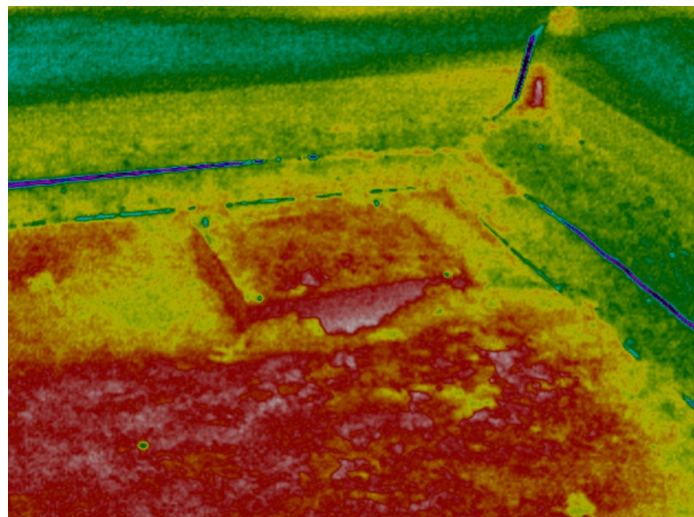
An interesting finding was the measurement of the control segment of the green roof on the Figure 6. It is made of rolled sheet metal and painted with an anti-corrosion agent. However, the implementation in the layers of the roof caused the segment to be almost invisible on thermal images. Small temperature differences are caused by the irregular thickness of the substrate around the segment, as well as inaccuracy during the installation of the hydroaccumulation layer.

Fig. 6. Thermalvision image of control segment

The control segment therefore has no negative effect on the conduction of heat in the structure and is therefore not a thermal threat or a source of thermal bridges. In this case, the segment is not sufficiently covered with substrate and therefore we can see the square outline of the structure in the picture. In cases where it would be properly sprinkled and lined with hydroaccumulation material, the temperature difference in the surroundings will be minimal.
