## Completion and Utilization of the Rehabilitated Central Tailing Heap of Jan Šverma Mine in Žacléř

In the article, the authors focus on the continuation of restoration and rehabilitation in the west part of the Central Heap and on the completion of rehabilitation work on the Central Heap, which is connected with the evaluation of subsequent use of rehabilitated land. In [1][2], the results of the first stage of restoration and rehabilitation of the Central Heap of the Jan Šverma Mine in Žacléř with the climax in the year 2009, when 11 hectares of total 18 hectares were grassed down, were already presented. This introductory part was followed by other rehabilitation works focused on reshaping the Heap to create stable slopes with safe slope

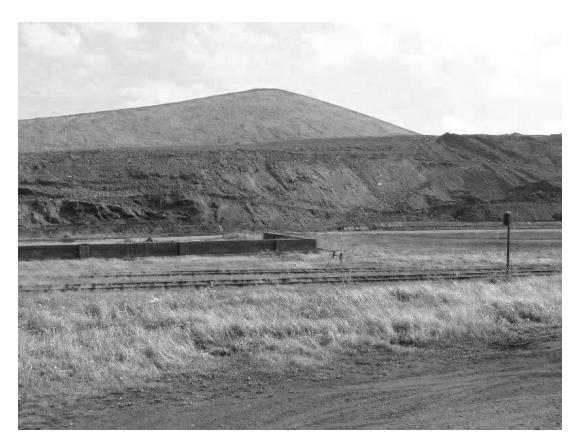
Fig. 1. A view of the JŠM Central Heap in March 2011 [3] Rys. 1. Widok centralnej hałdy JŠM w marcu 2011 [3]

With reference to a considerable time gap between the elaboration of project documentation optimization (1999) and the commencement of rehabilitation works (2004) and with reference to the changes in the very Heap (spontaneous sliding, etc.) in this period, the need to bring the project up to date arose. For the above-mentioned reasons, updated documentation concerning the rehabilitation of the Central Tailing Heap of the JŠM was prepared in October 2004. The mentioned documentation dealt with the entire Heap with the exception of its west part adjacent closely to the premises of the JŠM. The second stage of Heap rehabilitation lasted by the year 2010, Fig.1. The authors provided information on its course in [2].

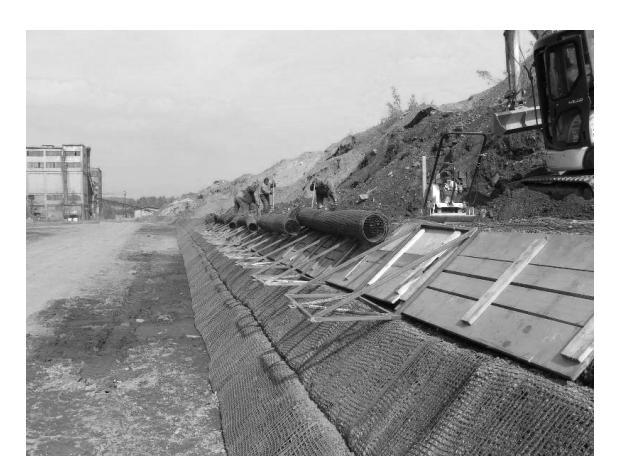
Fig. 2. The geogrid-reinforced structure [3] Rys. 2. Struktura wzmocnionej geokraty [3]

The west toe of the Heap was stabilized within the whole length to the height of 5.40 m and within the width of 3 m by means of a geogrid-reinforced structure with a side slope of 1:1, see Fig. 2.

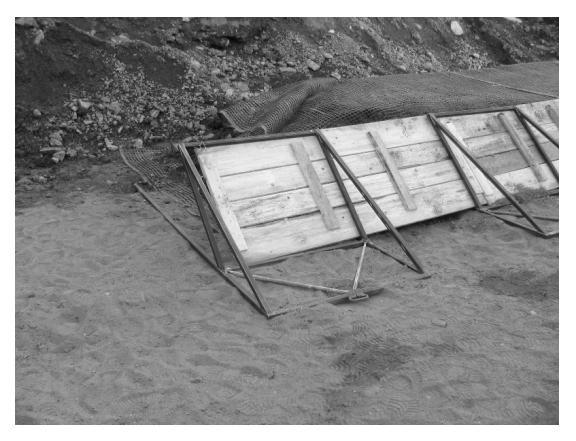
Fig. 3. The lower part of the west Heap slope [3] Rys. 3. Dolna część zachodniego zbocza hałdy [3]

Works in the lower part of the Heap represented the suitable grading of the area between the crest of the geogrid-reinforced toe in the west and the transport berm. In the area of interest, the tailings were locally removed from the Heap, loaded on trucks and transferred and deposited into uncompacted fills so that the designed shape could be obtained. Subsequently, the new graded surface was levelled by a bulldozer, Fig. 3.

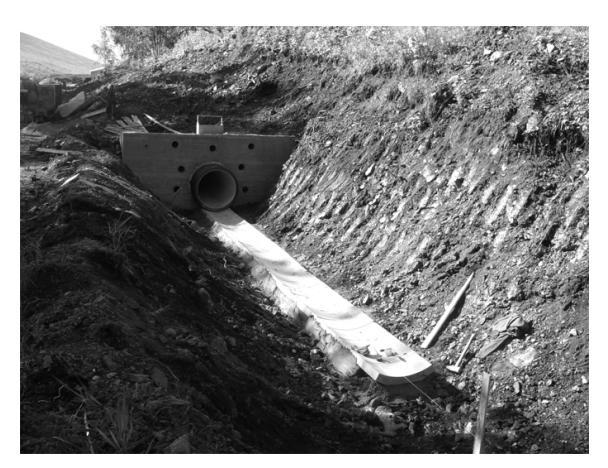
Fig. 4. An example of ground shaping in the Central Heap – ditches and protective bunds [3] Rys. 4. Przykład ukształtowania terenu centralnej hałdy – rowy i wały ochronne [3]

In the framework of ground shaping, ditches following the ditches constructed in the previous phase of construction works were dug. The material excavated from the ditches was used in pro-

tective bunds; the excess material was used for the completion of shaping the Heap, Fig. 4, 5.

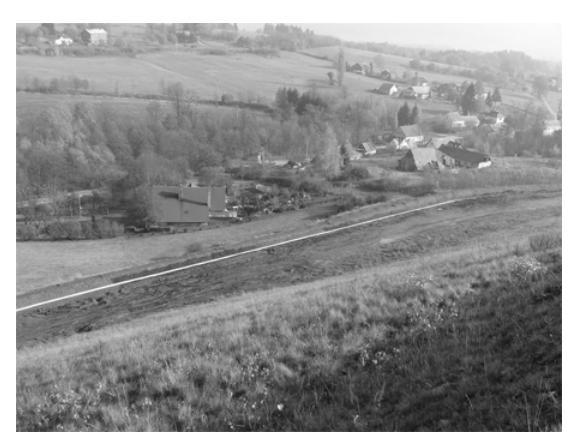
Fig. 5. An example of ground shaping in the Central Heap – ditches [3] Rys. 5. Przykład ukształtowania terenu centralnej hałdy – rowy [3]

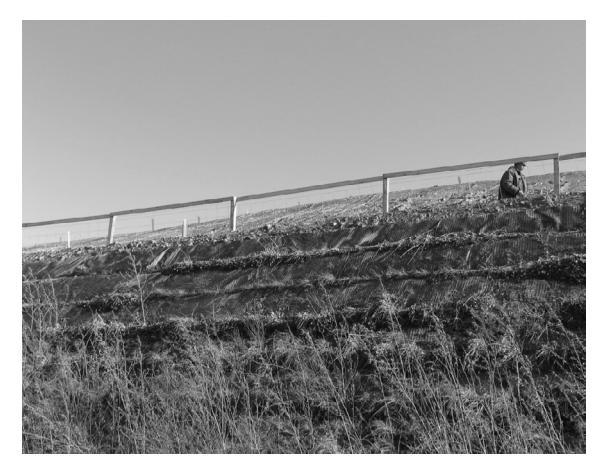
Fig. 6. The geogrid-reinforced structure with a retaining grid and shrub planting [3] Rys. 6. Struktura wzmocnionej geokraty wraz z zaprojektowaną siatką i sadzeniem krzewów [3]

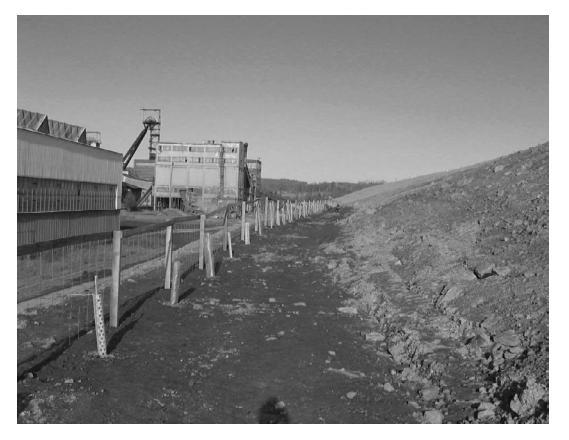
Fig. 7. The geogrid-reinforced structure with a retaining grid and shrub planting [3] Rys. 7. Struktura wzmocnionej geokraty wraz z zaprojektowaną siatką i sadzeniem krzewów [3]

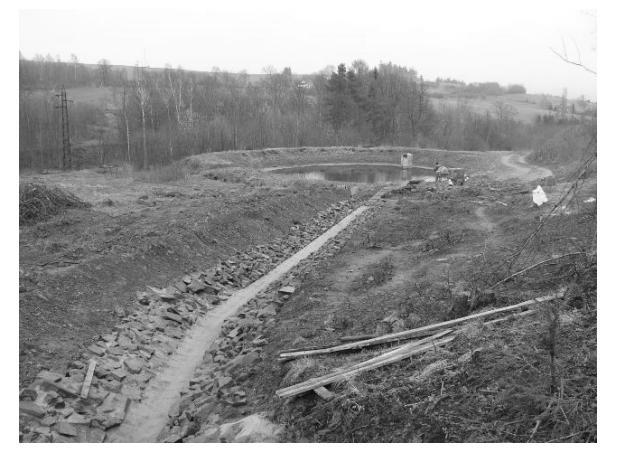
Fig. 8. Ditches are reinforced with stones [3] Rys. 8. Rowy wzmocnione kamieniami [3]

Drainage is carried out by a system of ditches connected to sections already constructed in the previous stage of construction work. In the places where the route of the ditch was in contact with transport operations and in sections with a steep incline, and thus the risk of destruction by erosion, the laying of pipes was designed, Fig. 8. With regard to mechanical-physical properties, plastic corrugated pipes were selected; they can withstand heavy loads even without additional concrete encasement, Fig. 9. The ditches themselves are reinforced with stones (up to 80 kg/pc). This solution makes them able to resist torrential rains, fully complies with local conditions and has

• Stones weighing less than 80 kg each – it is a case of quarry stone used in the wedge-shaped hand placed rockfill for reinforcement of drainage trenches. The supplier had to prove the suitability of stone for the given purpose (absorption, frost susceptibility, compressive strength).

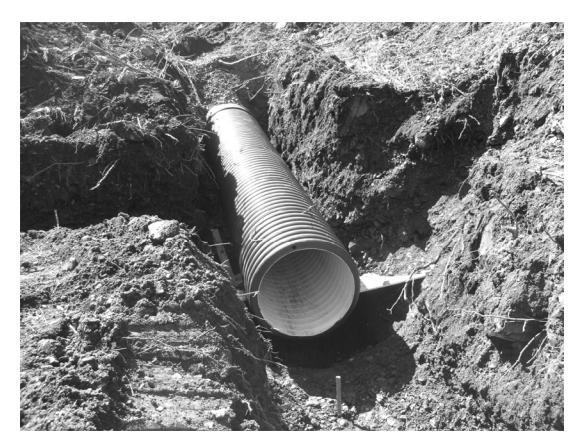
Fig. 9. Plastic corrugated pipes [3] Rys. 9. Plastikowe rury faliste [3]

• Plastic corrugated pipes – pipes BOCR Polycor DN 100/851/8 were used for the structure.

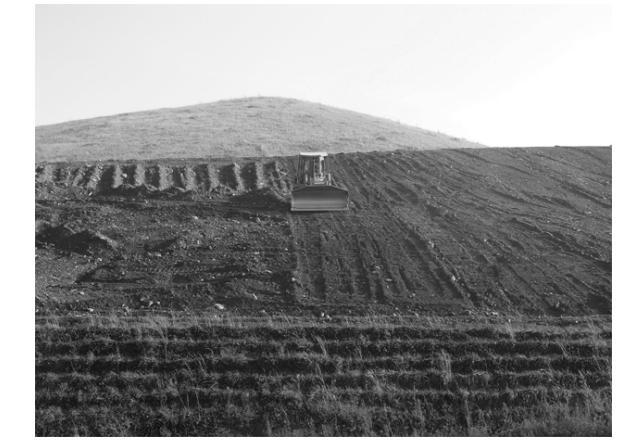
Fig. 10. An example of revegetation of the Central Heap of JŠM [3] Rys. 10. Przykład wegetacji ma centralnej hałdzie JŠM [3]

The way of establishing grasses on the reshaped surface of the Heap was designed based on obtained experience of revegetation of the previous part of the Heap, where, owing to unfavourable climatic conditions and especially pedological conditions, any optimal state had not been reached at the first attempt. For this reason, grassing was carried out by hydroseeding or by manual sowing with raking the seed in; the required amount of nutrients was added to the barren tailings by means of suitable fertilization, Fig. 10. An increased attention was paid to adequate irrigation.
